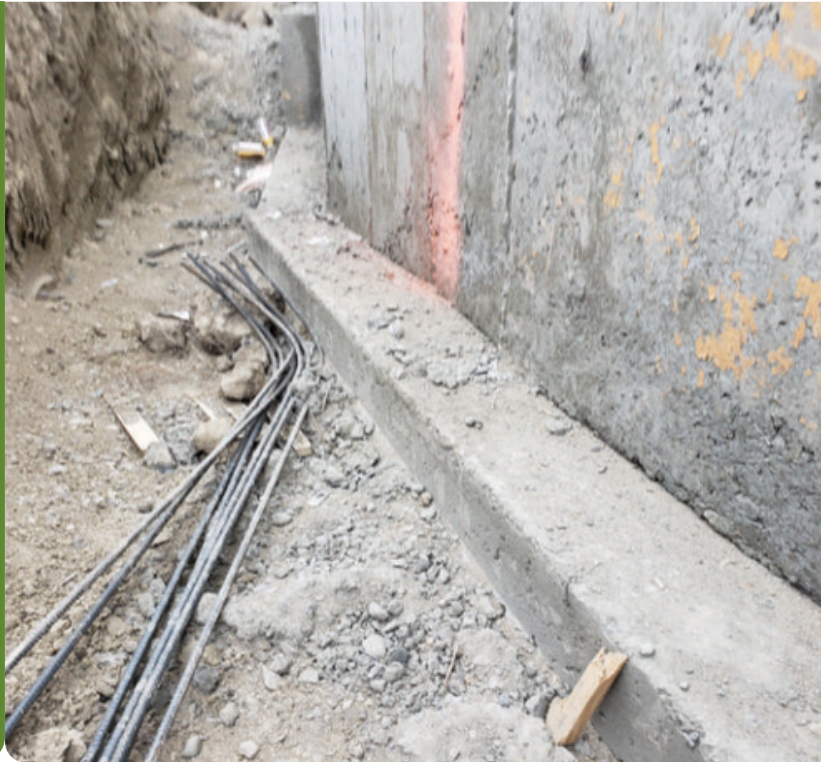
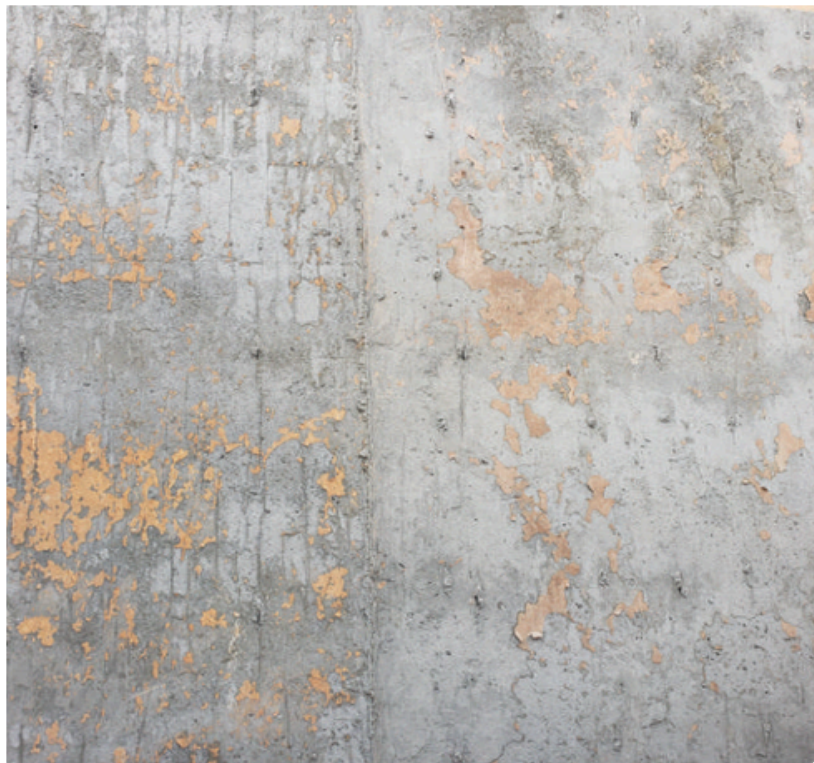
After the shoring was pulled away the Hulk Installers got a good look at the scope of work. Any voids and cracks were marked with bright spray paint as these areas needed our Flexible Mastic to seal them completely. Special attention is always paid to the cold joint where the footing slab meets the wall.

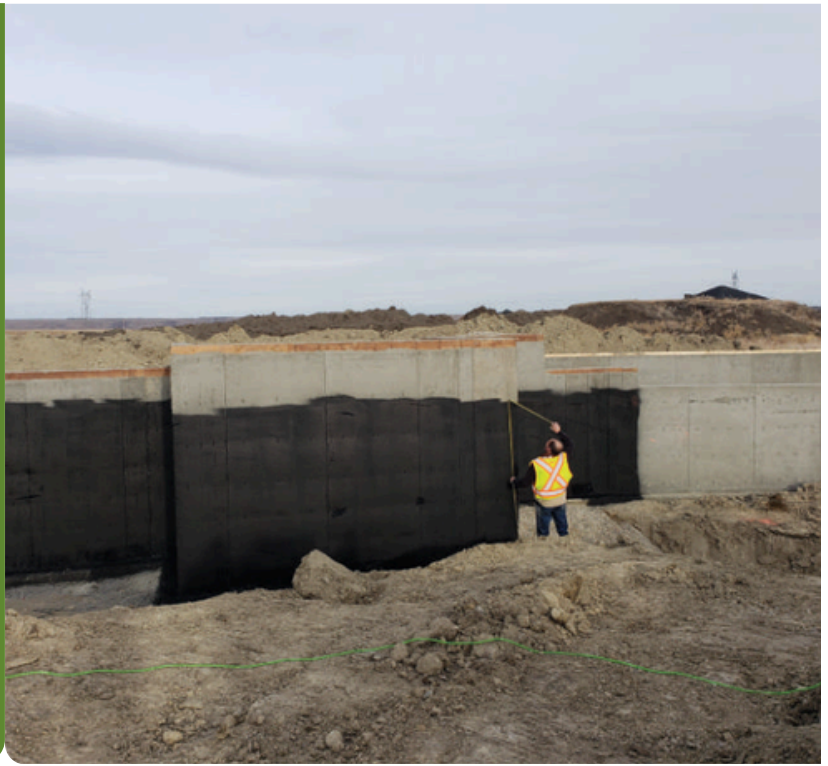
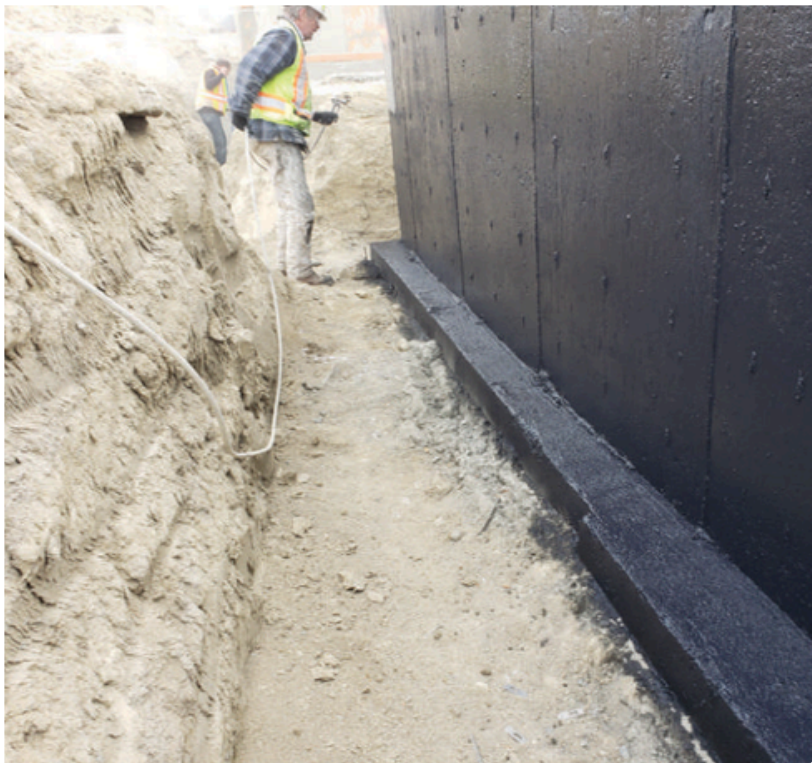
As the first coat goes on heights need to be checked to make sure the waterproofing exceeds the grade-line. This can be easily marked out with a thick chalk-line before work commences. The nice thing about Hulk's Acrylic versus other products is it is 100% UV stable with less than 1% fade annually, so you don't need to hide it away from the sun.

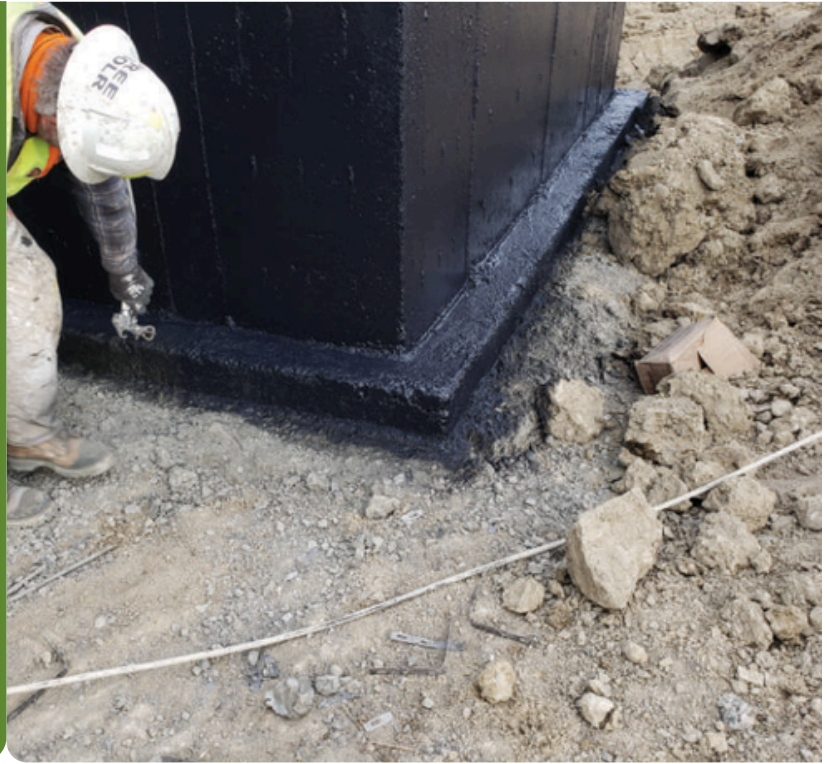
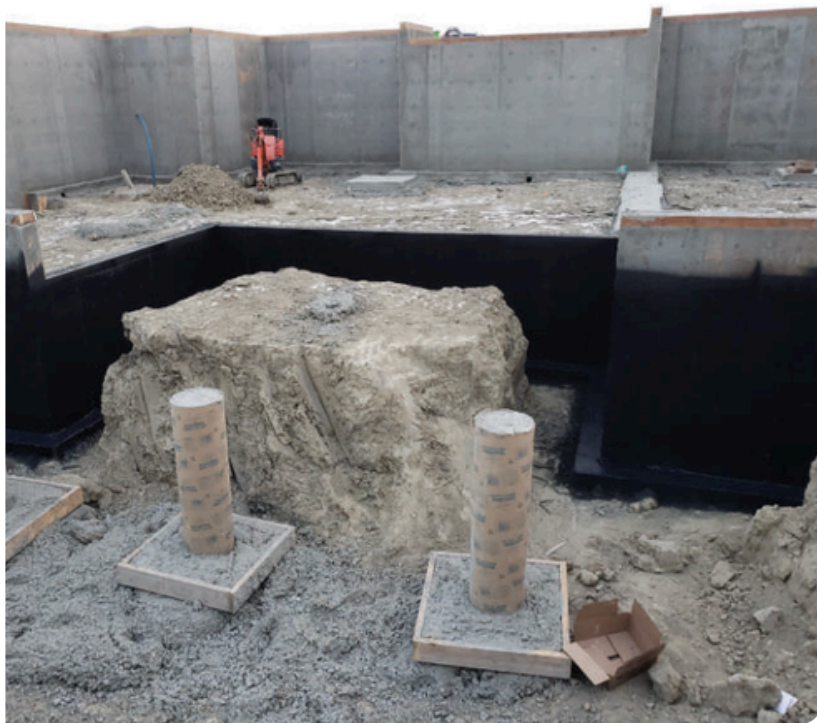
The footing is extremely important, especially the joint that has been filled where the wall meets the slab. Double coverage on this area is always recommended, as it is a horizontal surface rather than a vertical surface.

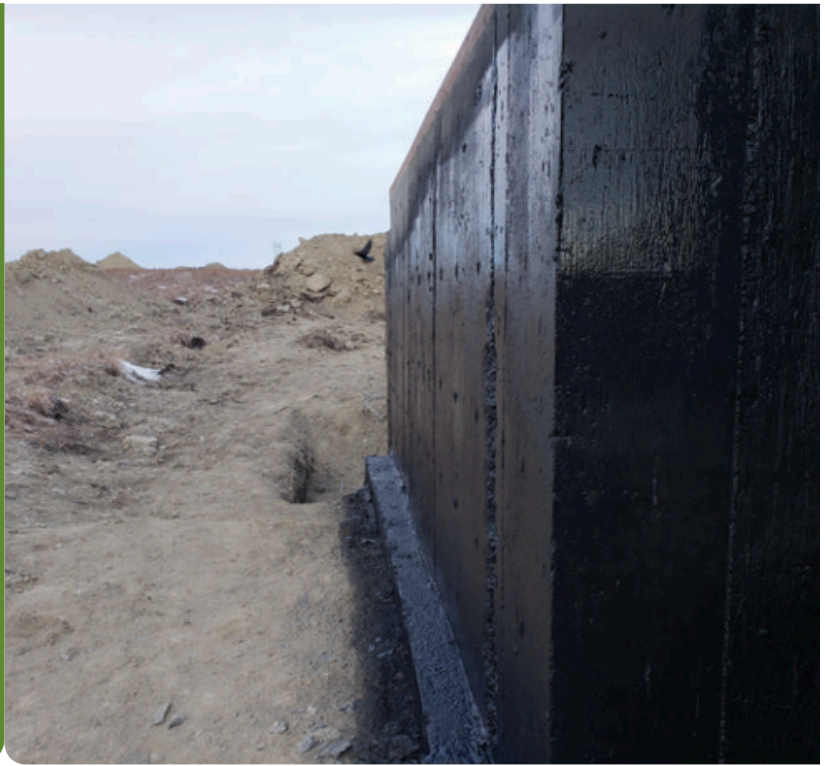
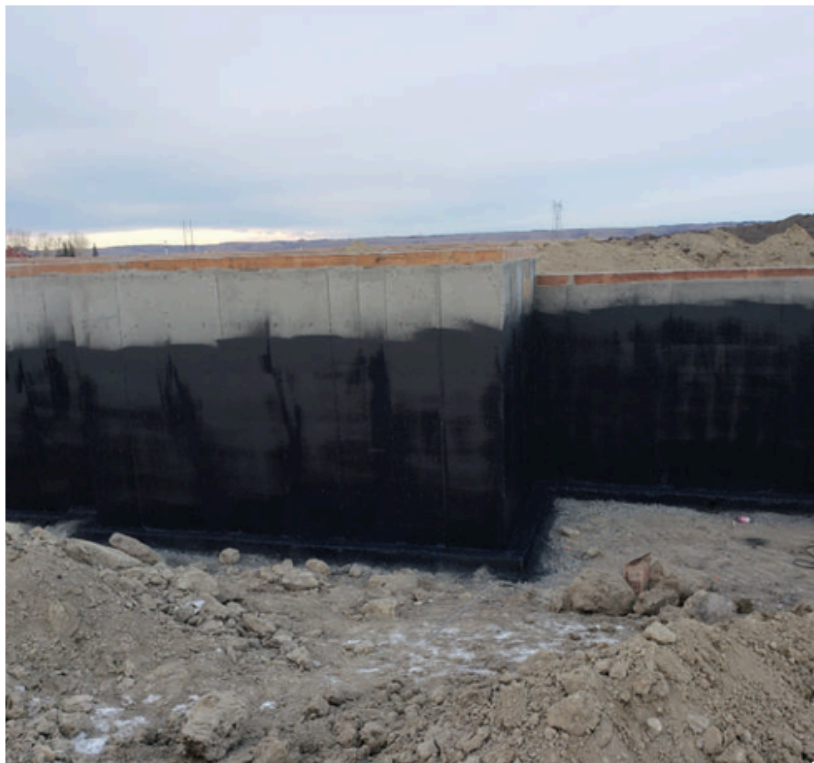
After the second coat is installed the installer has achieved either a Class 2 vapor barrier at 18-25 mils or a Class 1 vapor barrier at 26+ mils. Different jobs will have different specifications for permeability that is required for either damp-proofing or water-proofing. One factor that may affect these requirements is the amount of time that the concrete was poured before coating. Leaving the membrane semi-permeable may be requested so that the concrete can achieve a full cure faster.
